# Use of Magnetic Tomography Technology to Evaluate Dowel Placement

PUBLICATION NO. FHWA-IF-06-006

NOVEMBER 2005

6. Performing Organization Code	
7. Author(s) <b>H. Thomas Yu and L. Khazanovich</b>				8. Performing Organization Report No.	
9. Performing Organization Name and Address <b>ERES Consultants 505 West University Ave Champaign, IL 61820</b>				10. Work Unit No. (TRAIS)

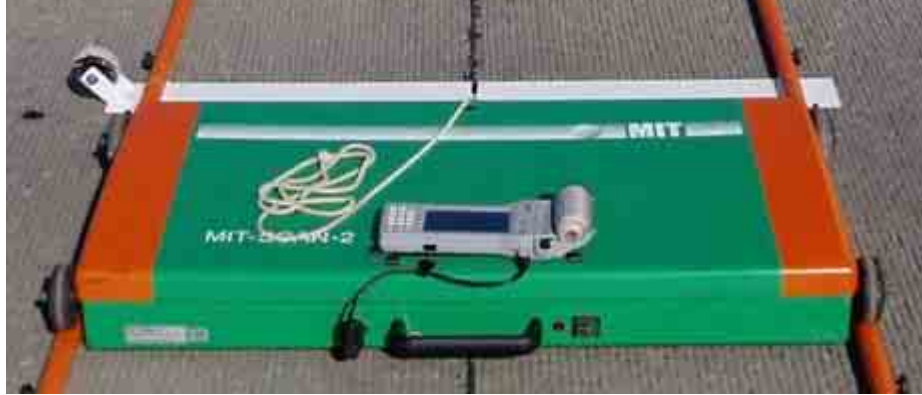
Figure 1. MIT Scan-2, consisting of the sensor unit (a rectangular, green box), onboard computer, and glass-fiber-reinforced plastic rail system.

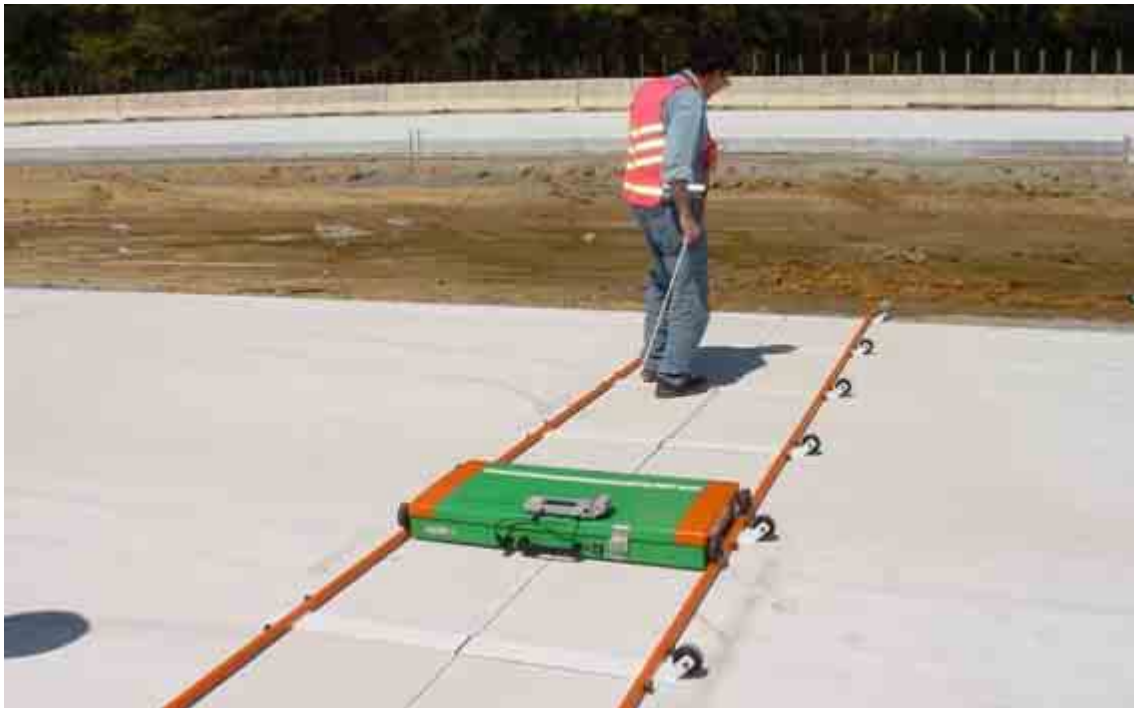
Figure 2. Scanning a joint using MIT Scan-2.

Figure 2 shows a joint being scanned using MIT Scan-2. Scanning a joint takes less than a minute. The field data analysis is fully automated, and results are produced in less than a minute after scanning. The onboard computer is equipped with a printer to provide a printed output in the field. Example field results are shown in Figure 3. The test data are stored in a PCMCIA flash memory card. Data for up to 600 joints (single lane) can be stored in the 32-megabyte (MB) memory card provided with the device. This is typically more than adequate storage, and the data can be transferred easily to a laptop computer by simply removing the PCMCIA card from the onboard computer and plugging it into the PCMCIA card slot of a laptop computer.

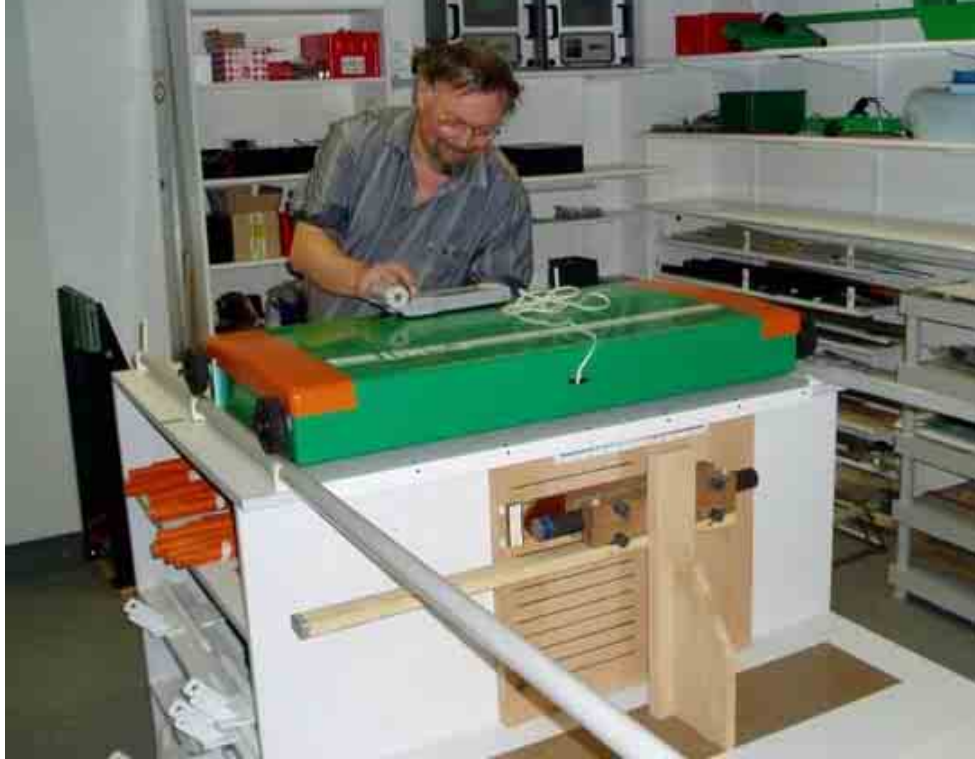
Figure 5. Calibration measurements being taken at MIT GmbH laboratory.

Each MIT Scan-2 unit is individually calibrated to each type of bar that will be detected using the device to provide very accurate results. During calibration, measurements are taken over the entire range of bar positions and orientations to correlate the response signals to the known bar positions and orientations. The testing results are used to develop a device-specific parameter file for each type of bar. The bar type is defined by the bar dimensions (diameter and length) and metal composition (e.g., steel, solid stainless steel, or stainless steel clad).

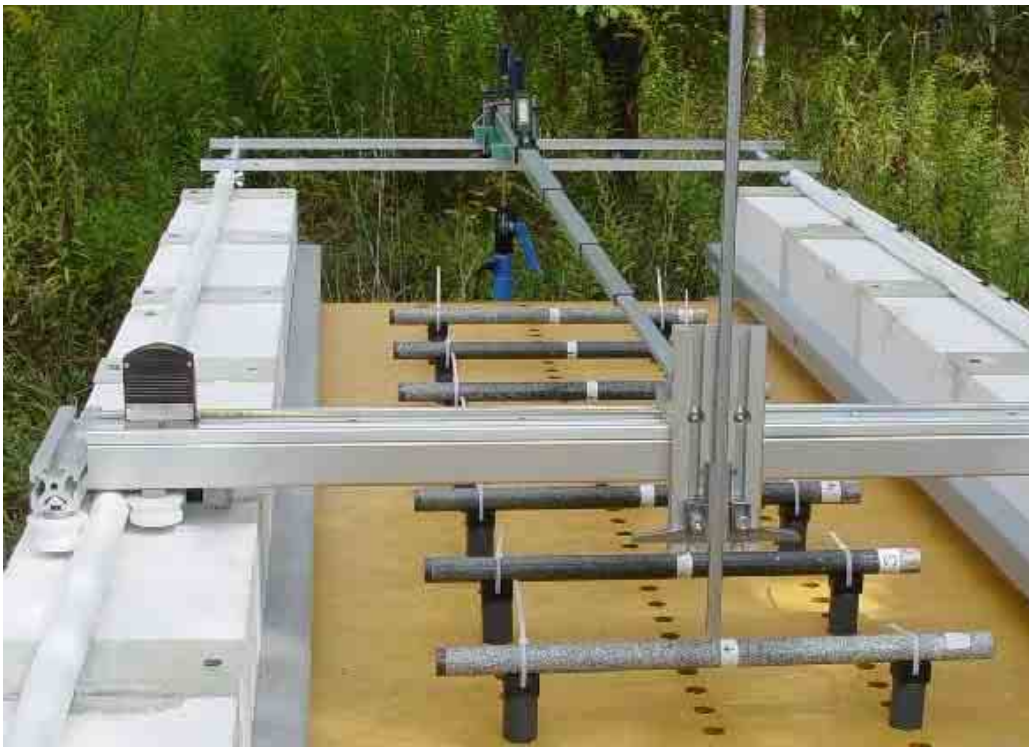
Figure 6. Test track at MIT GmbH for validation of calibration results.

The accuracy of MIT Scan-2 results, determined based on laboratory testing, were verified using the results of testing conducted at the MIT GmbH test track (Figure 6). The test track offers the means of taking very accurate measurements of the actual dowel bar positions under simulated field conditions. A factorial of tests was conducted covering the full operating range of MIT Scan-2 using seven dowel bars. In each case, six of the dowel bars were placed with similar side shift and minimal misalignment, and the position of one of the middle dowels was varied according to the factorial design of the testing program. This test simulates the conditions in real joints, in which most of the bars are in good alignment but one bar has a varying degree of misalignment. The results of this test will show the effects of any influence of neighboring dowel bars on measurement accuracy.

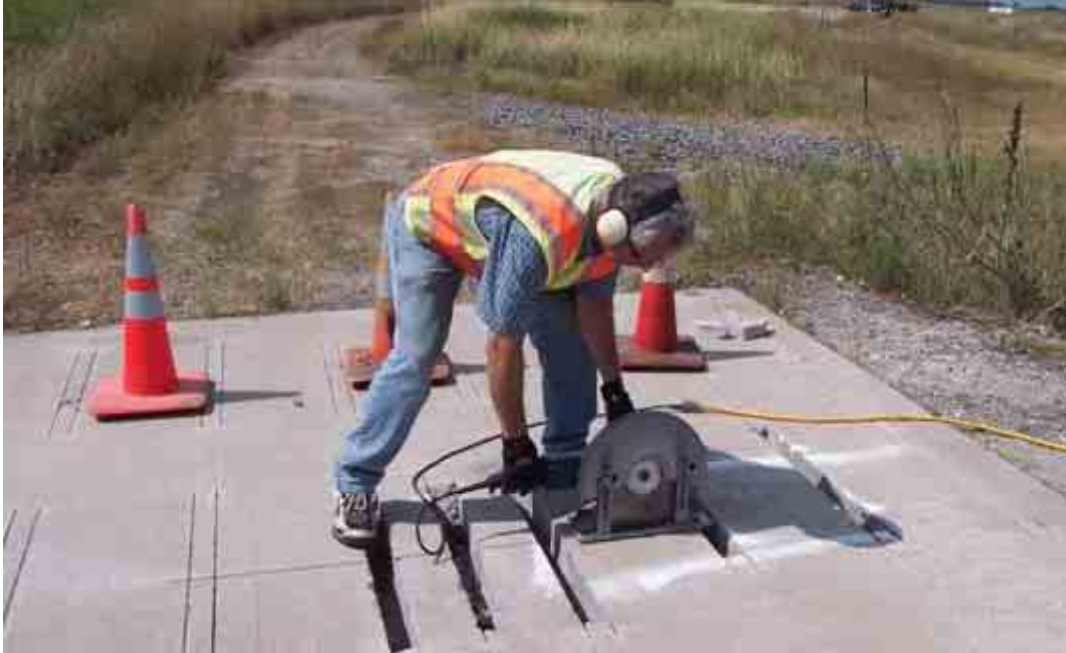
Figure 7. Saw cut being made on test slab to simulate a joint at the MnRoad facility.

Most of the laboratory testing was conducted at the MnRoad facility. MnRoad constructed a slab with slots and simulated joints cut into the test slab (Figure 7) for this study. The dowels were placed in the slots at various depths and orientation. Measurements were then taken using MIT Scan-2 and compared to manual measurements. The slots provided a stable platform for holding the dowels in place during hand measurements and during MIT Scan-2 testing (Figure 8). For example, shifting the rail, rather than moving the dowel bar, ensured that the orientation of the dowel bar remained constant throughout the series of testing that was conducted to evaluate the effects of side shift.

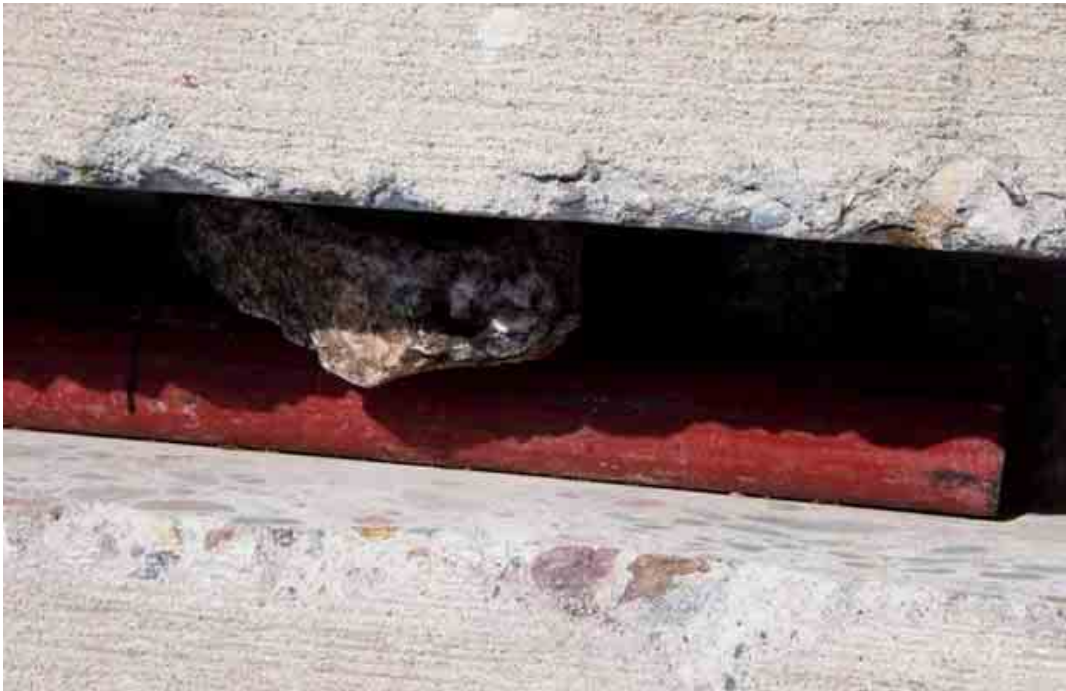
Figure 8. Dowel bar wedged in a slot of the test slab at the MnRoad facility.

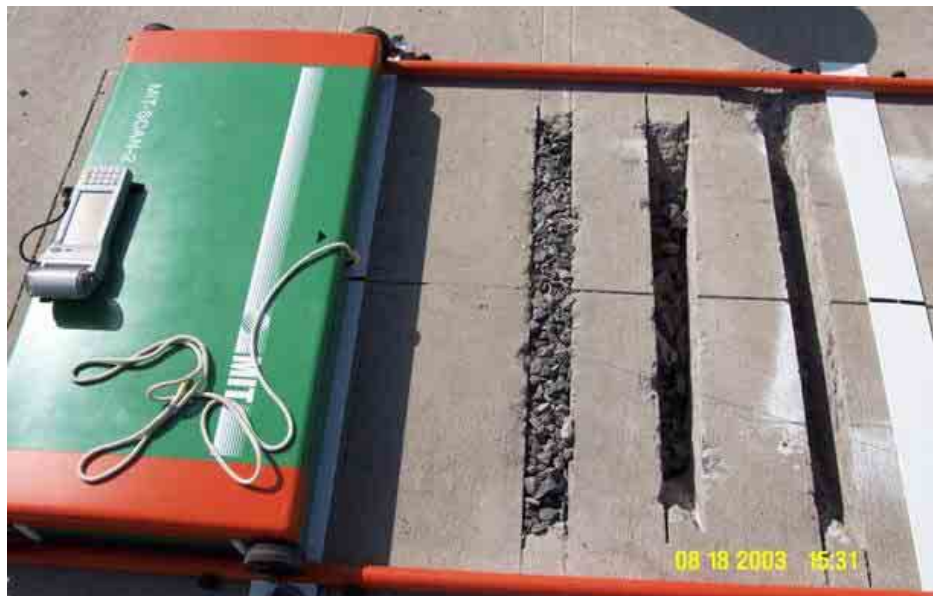
Figure 9. Dowel covered with aggregate for the evaluation of the effects of cover material.

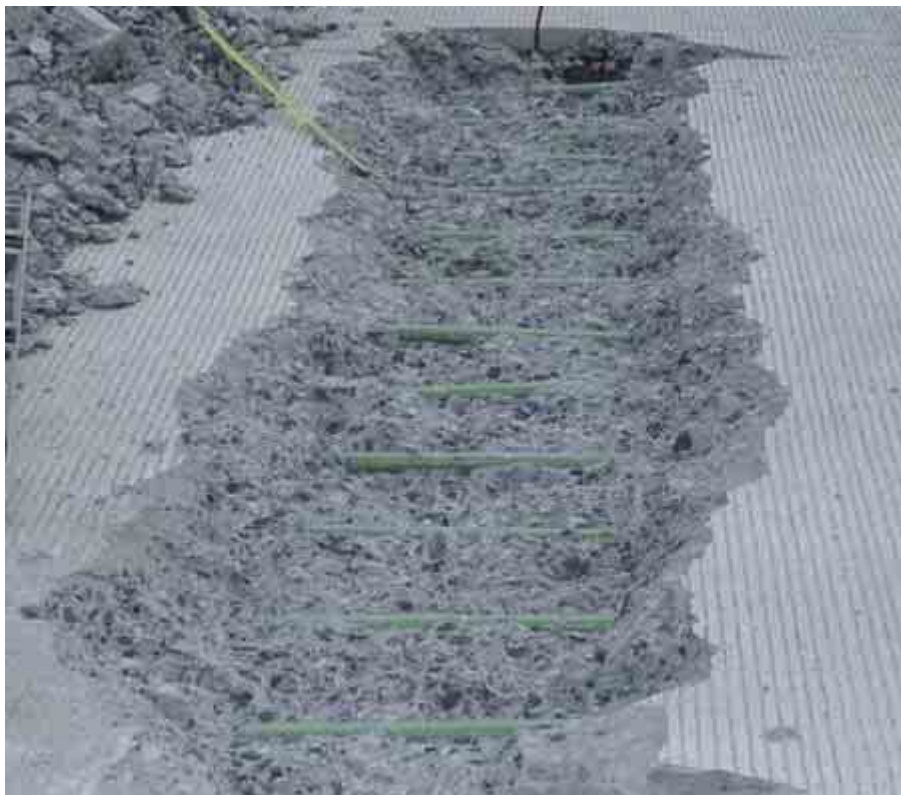
Figure 10. Exposed dowel bars for validation of MIT Scan-2 results.

Further evidence that the cover material does not affect MIT Scan-2 results is provided in the results of a field test conducted by the Ontario Ministry of Transportation, in which pavement joints were exposed after scanning to verify MIT Scan-2 results (Figure 10). The results from this test are summarized in Table 4.

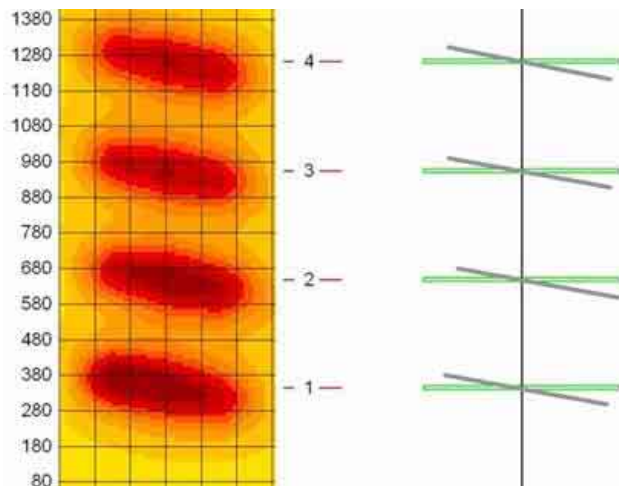
Figure 11. Apparent horizontal misalignment due to joint skew.

- The horizontal misalignment range of  $\pm 40$  mm ( $\pm 1.6$  in.) is not sufficient for testing skewed joints. Skewed joints need to be tested with the rail set parallel to the joint saw cut, which leaves the dowel bars at an angle with respect to the rail. The results thus obtained will show a uniform apparent horizontal misalignment corresponding to the skew angle in addition to the actual horizontal misalignment. The apparent horizontal misalignment corresponding to the typical joint skew angle (1 in 6) is 76 mm (3 in.) for 450-mm (18-in.) dowel bars. MIT Scan-2 must be able to accommodate this additional amount of apparent horizontal misalignment to enable testing on skewed joints.

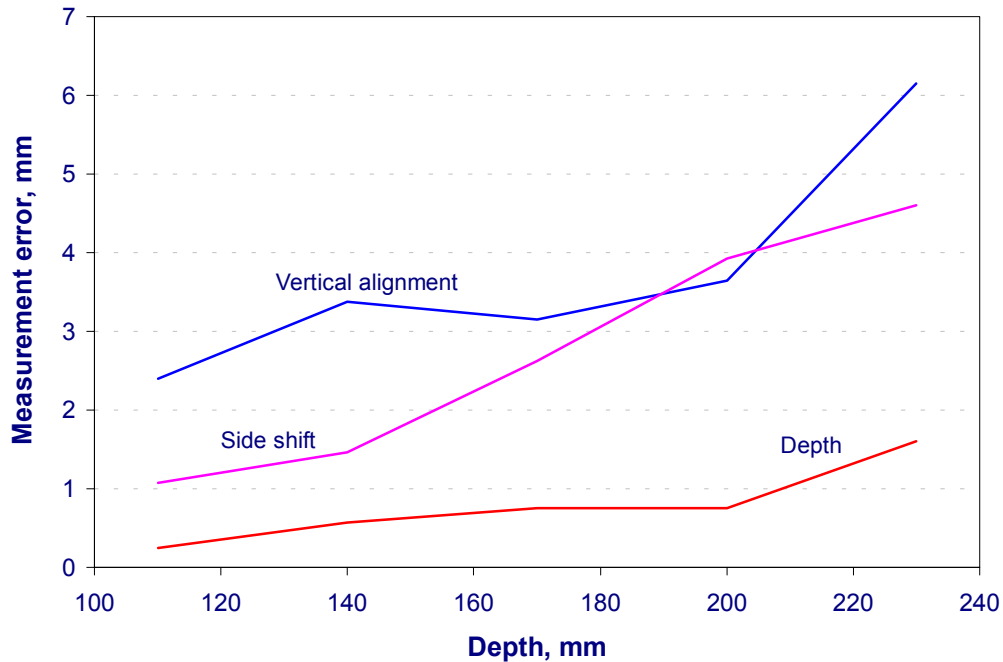
Figure 12. Sensitivity of measurement to bar depth for 32-mm (1.25-in.) dowel bar (MIT GmbH).

to about 200 mm (7.9 in.). At depths above 200 mm (7.9 in.), the measurement error increases rapidly. This is only a limitation for the devices that were optimized for highway applications, where the typical bar depths range from about 100 to 165 mm (4 to 6.5 in.). For testing thicker pavements, the signal strengths can be increased to shift the zone of accurate results upward. In fact, the signal strength of the devices shipped to the United States was reduced by half from the original design to accommodate testing that included dowel baskets. Excessively high signal strength causes the response signal to saturate the sensors, making it impossible to obtain any information about the dowel position.

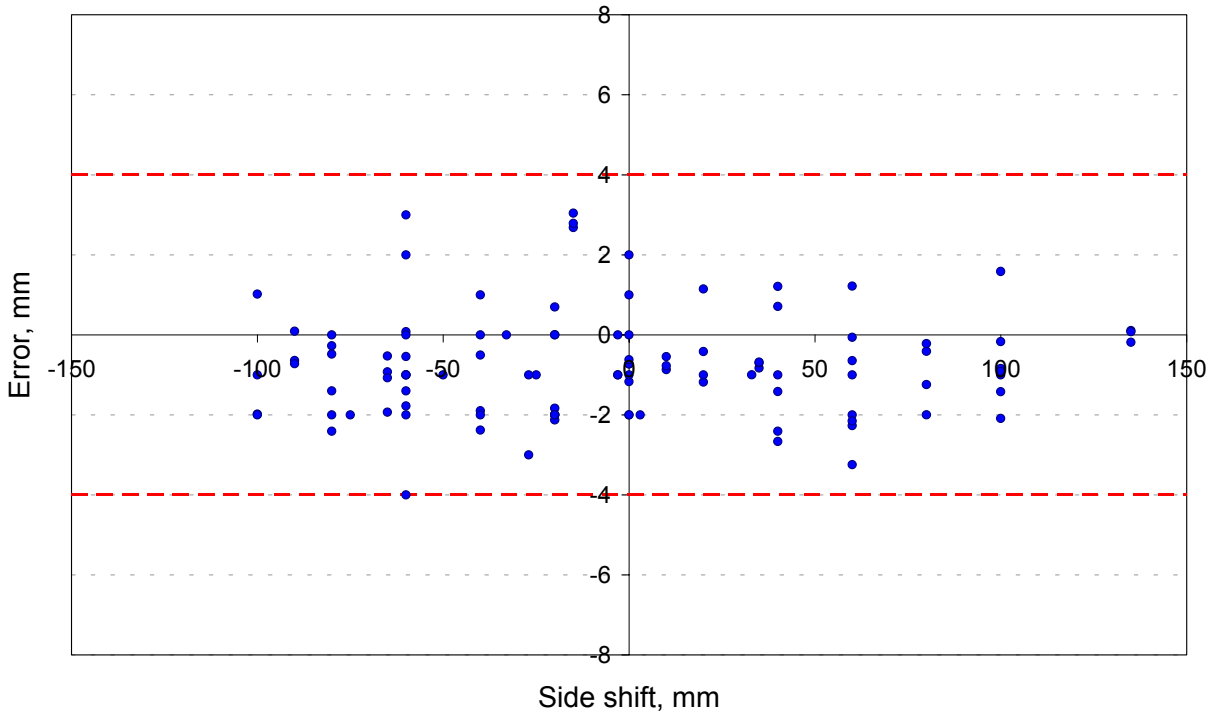
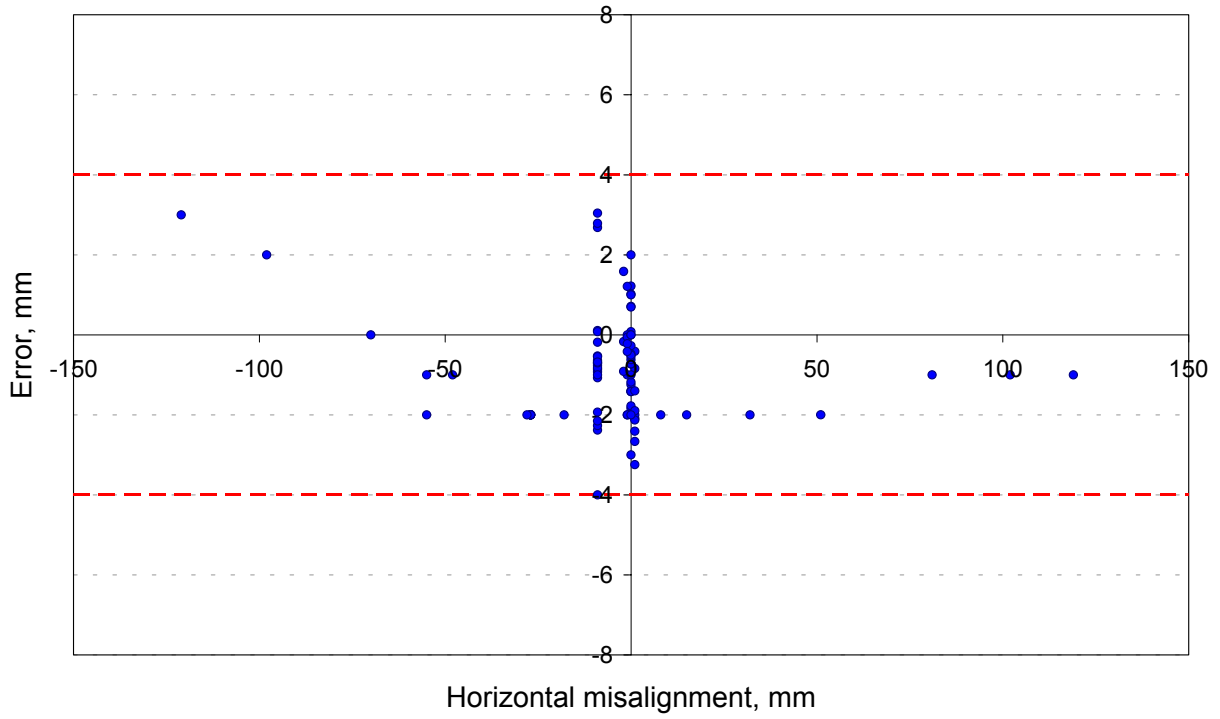
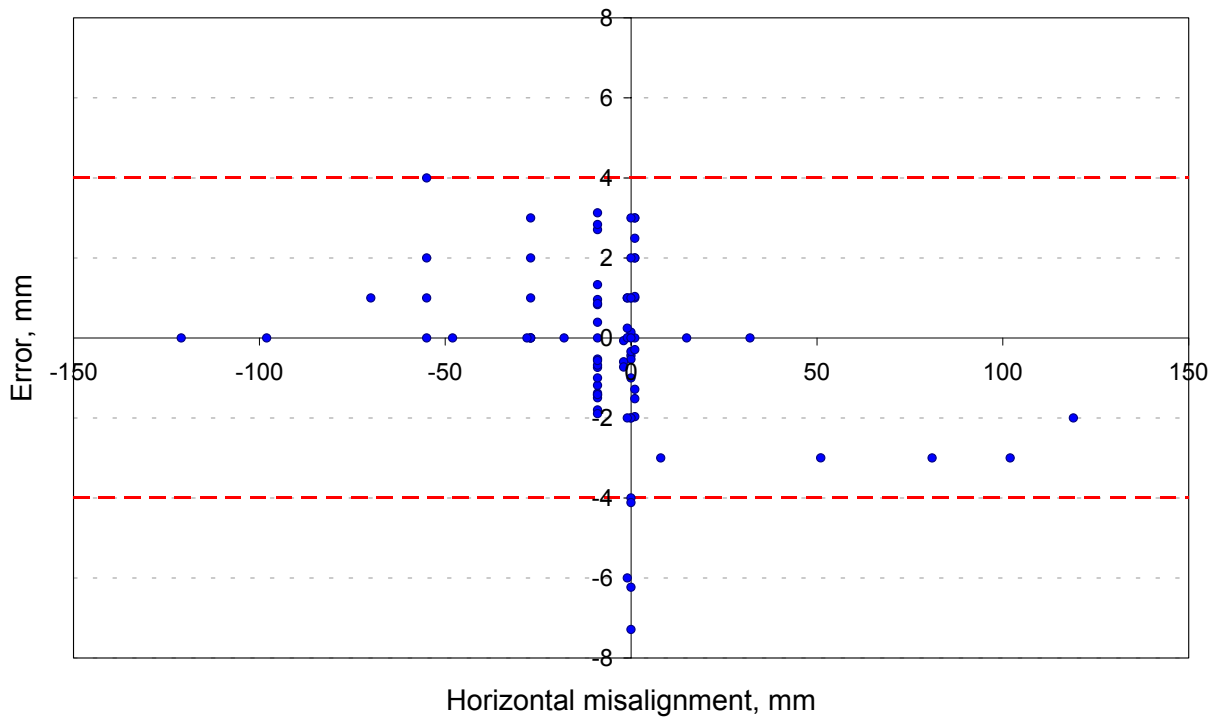
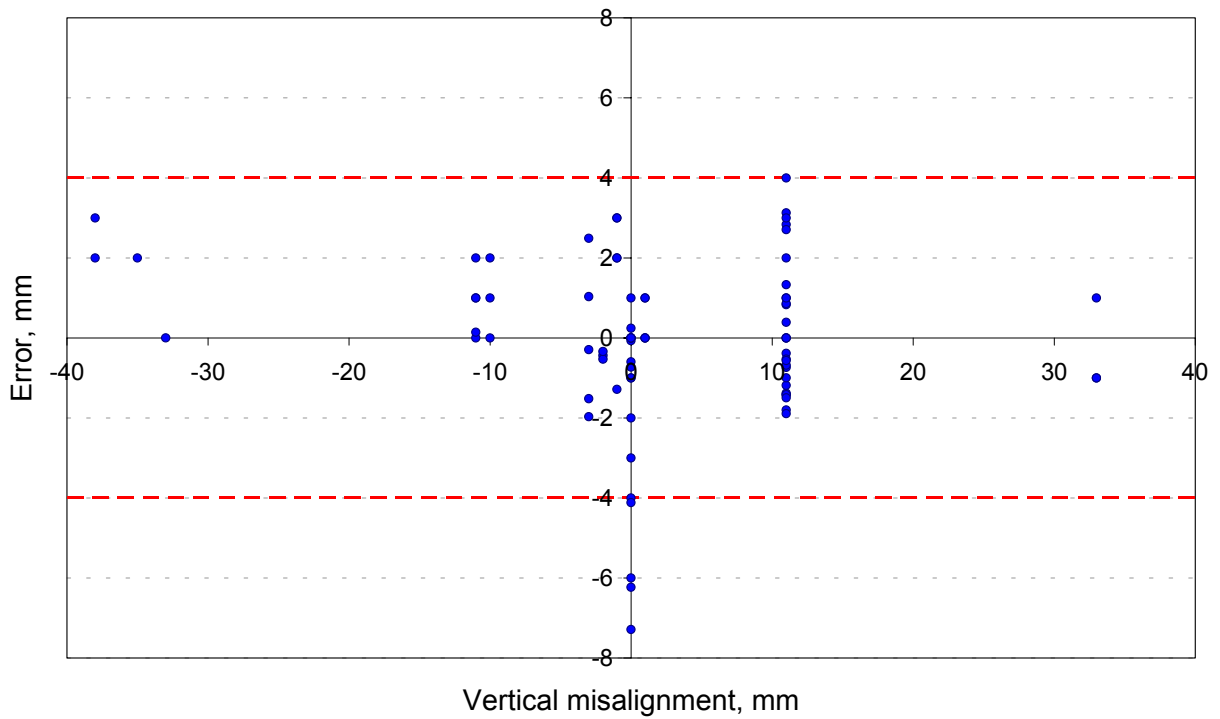
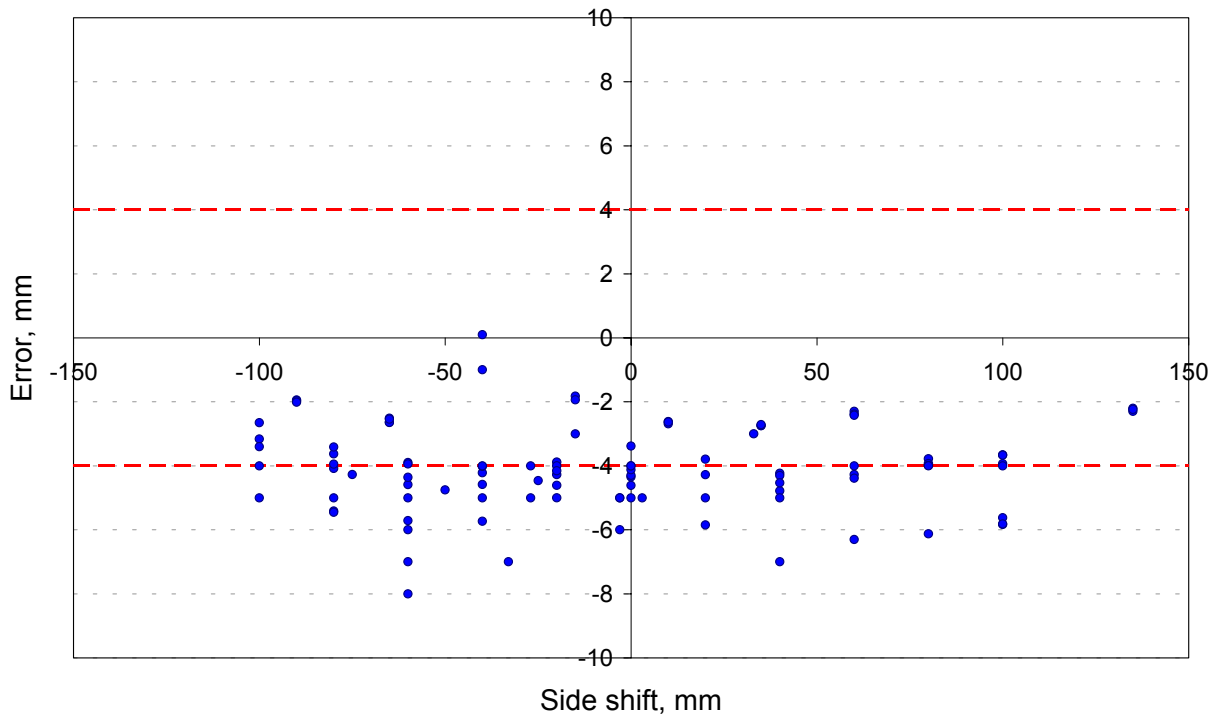
Figure 13. Measurement error on horizontal misalignment as a function of side shift.

Figure 14. Measurement error on vertical misalignment as a function of side shift.

Figure 15. Measurement error on horizontal misalignment as a function of bar depth.

Figure 16. Measurement error on vertical misalignment as a function of bar depth.

Figure 17. Measurement error on horizontal misalignment as a function of horizontal misalignment.

Figure 18. Measurement error on vertical misalignment as a function of horizontal misalignment.

Figure 19. Measurement error on horizontal misalignment as a function of vertical misalignment.

Figure 20. Measurement error on vertical misalignment as a function of vertical misalignment.

Figure 21. Measurement error on bar depth as a function of side shift.

Figure 22. Measurement error on side shift as a function of side shift.

The evaluation results are shown in Figures 13 through 22. The following can be observed from the test results:

Note that the operating range for horizontal misalignment is a range of misalignment ( $\pm 40$  mm [ $\pm 1.6$  in.]) plus a uniform rotation. Although the laboratory evaluation covered the full range of horizontal misalignment ( $\pm 120$  mm [ $\pm 4.7$  in.]), the tests were conducted using a single dowel bar. In an actual joint, extreme horizontal misalignments can cause the ends of neighboring bars to come very close to each other, which in turn can cause additional error due to overlapping response signal. On skewed joints, the magnitude of apparent horizontal misalignment is large, but a major portion of the registered horizontal misalignment is due to a uniform rotation caused by joint skew, which does not cause a problem for neighboring dowel bars. For the actual misalignment, the range originally specified for horizontal misalignment ( $\pm 40$  mm [ $\pm 1.6$  in.]) is more than adequate to cover all practical cases. If the actual horizontal misalignment exceeds  $\pm 40$  mm ( $\pm 1.6$  in.), the exact quantitative results are not important; it is sufficient to know that the horizontal misalignment is large.

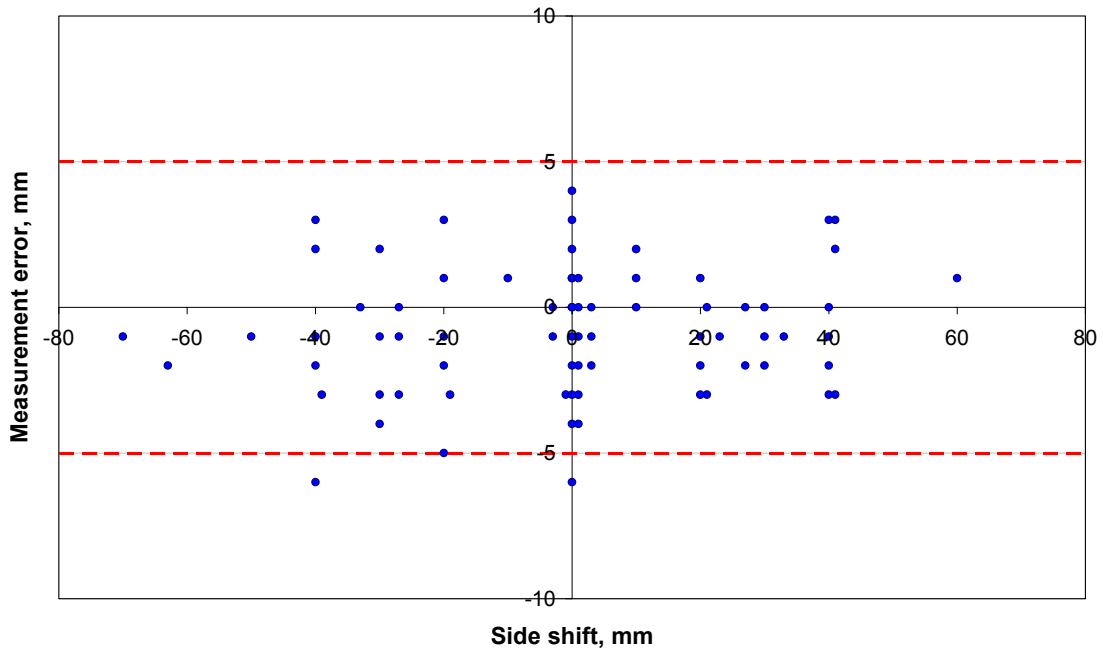
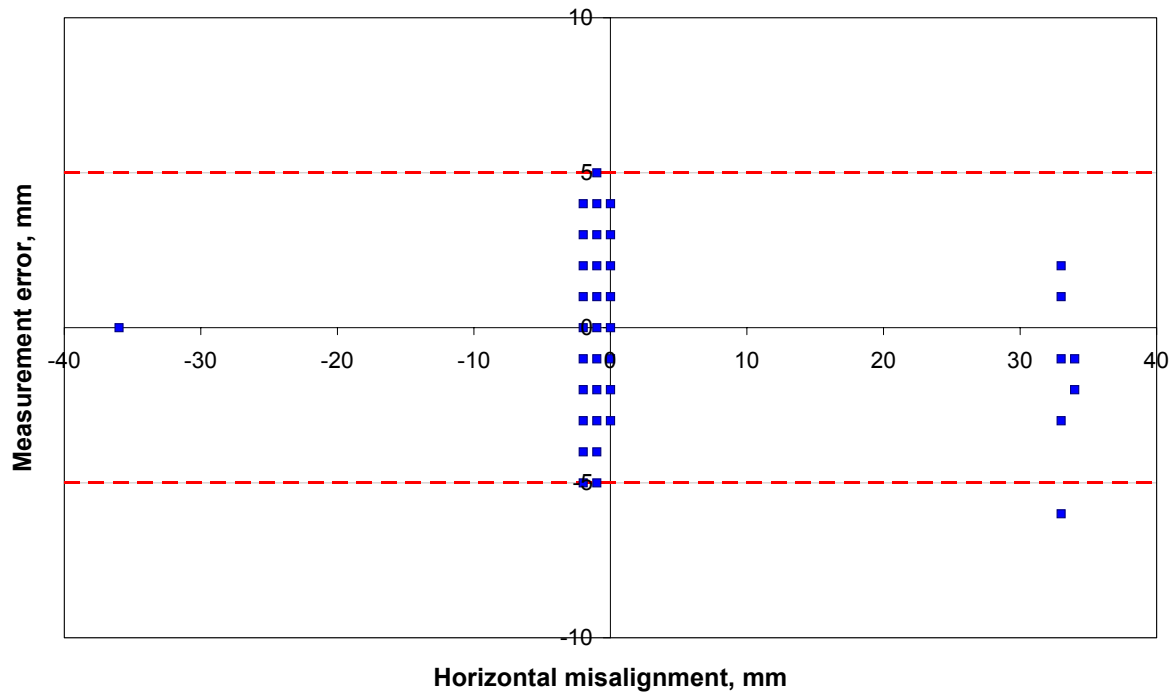
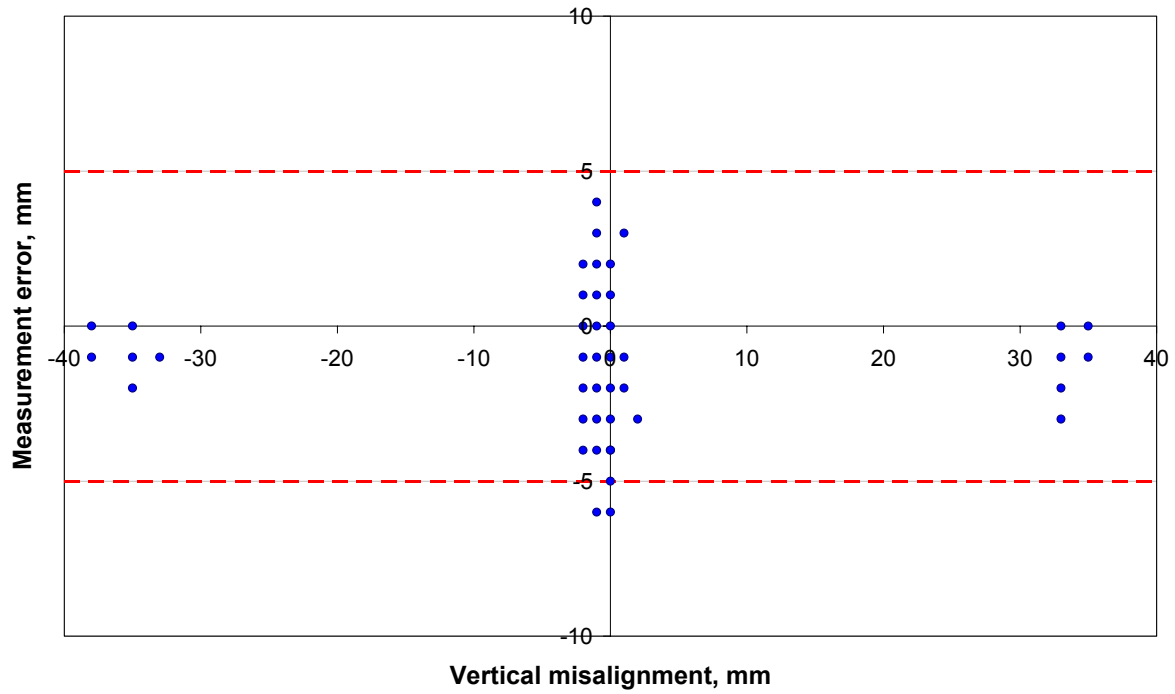
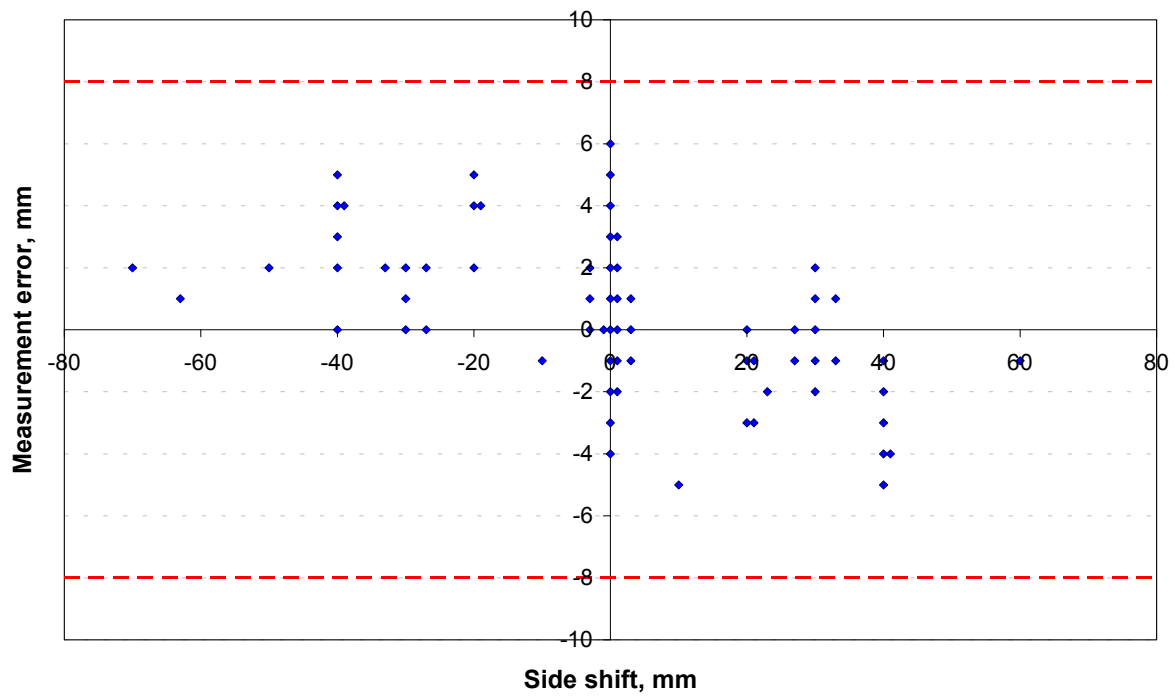
Figure 25. Measurement error on horizontal misalignment as a function of side shift (MIT test track).

Figure 26. Measurement error on vertical misalignment as a function of side shift (MIT test track).

Figure 27. Measurement error on horizontal misalignment as a function of depth (MIT test track).

Figure 28. Measurement error on vertical misalignment as a function of depth (MIT test track).

Figure 29. Measurement error on horizontal misalignment as a function of horizontal misalignment (MIT test track).

Figure 30. Measurement error on vertical misalignment as a function of horizontal misalignment (MIT test track).

Figure 31. Measurement error on horizontal misalignment as a function of vertical misalignment (MIT test track).

Figure 32. Measurement error on vertical misalignment as a function of vertical misalignment (MIT test track).

Figure 33. Measurement error on depth as a function of side shift (MIT test track).

Figure 34. Measurement error on side shift as a function of side shift (MIT test track).

results, but not to the extent shown in Figure 21. Figure 34 shows that the side shift results are well within the specified range of accuracy, which suggests that the bias shown in Figure 22 for the laboratory testing may very well be due to errors in manual measurements.

The validation test results confirmed the findings of the laboratory evaluation, that MIT Scan-2 provides accuracy of  $\pm 5$  mm ( $\pm 0.2$  in.) with 95 percent reliability. The measurement errors exceeded  $\pm 5$  mm ( $\pm 0.2$  in.) on a few occasions. However, the error in horizontal misalignment measurements exceeded  $\pm 5$  mm ( $\pm 0.2$  in.) only 0.6 percent of the time, and the error in vertical misalignment measurements exceeded  $\pm 5$  mm ( $\pm 0.2$  in.) only 1.2 percent of the time. As noted under laboratory testing, it is important to remember that the conclusions regarding the accuracy and reliability of MIT Scan-2 are valid only in the absence of any external influence (mainly, the presence of foreign metal, such as tie bars in close proximity).

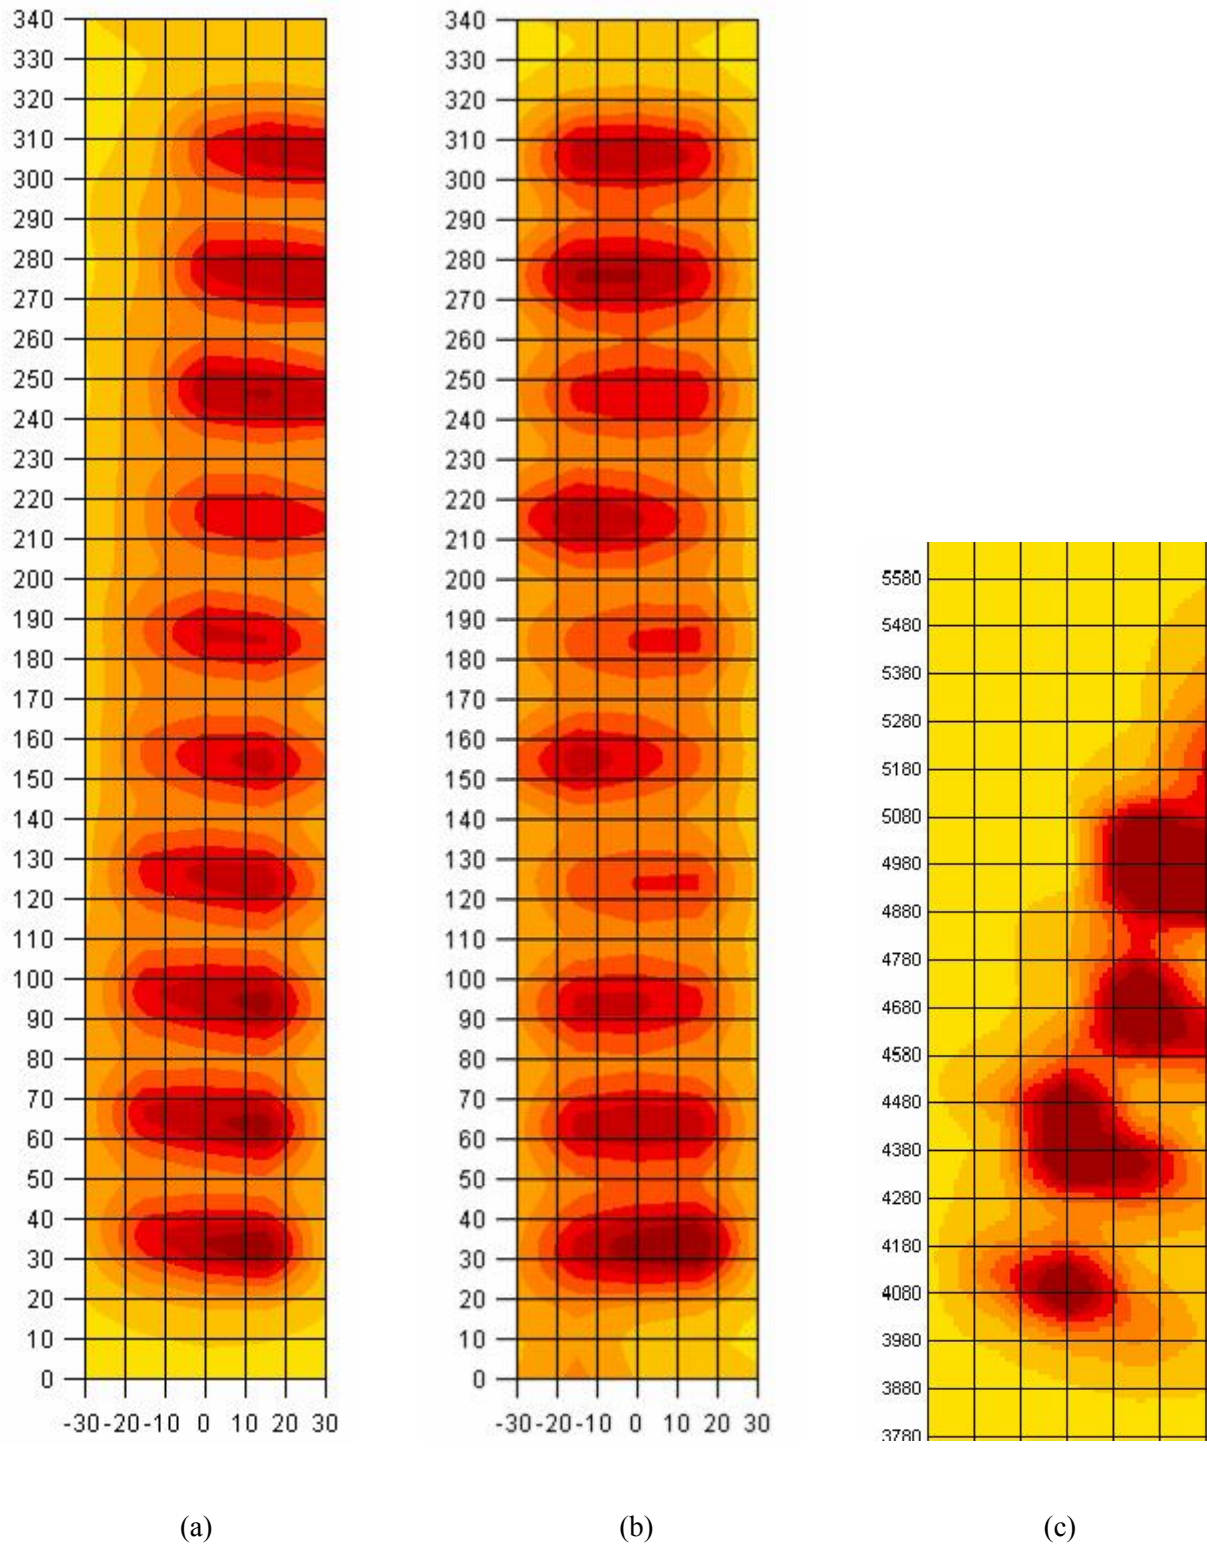
Figure 35. Examples of problem baskets: (a) basket is deformed, (b) basket is pulled apart, and (c) basket is severely deformed and rotated almost completely off of the joint.

For dowel baskets, the qualitative results from MIT Scan-2 (e.g., approximate numerical results and graphical output) can be as useful as the more precise numerical results obtained by having the correct basket calibration. In general, with proper inspection prior to paving, excellent dowel alignment can be achieved as long as the basket does not move during paving. The type and number of pins used to anchor the basket in place is the critical factor. If the basket is properly anchored, the dowel alignment will not change during paving. However, if the baskets are not adequately anchored, the basket can deform, burst open, or move during paving. The occurrences of such problems are very easy to detect from graphical output of MIT Scan-2. Figure 35 provides examples, clearly visible in the graphical output, of the problems resulting from inadequate anchoring of dowel baskets. These types of problems cause severe dowel misalignment, which can also be reliably detected from the approximate numerical results obtained using standard calibration (i.e., without basket-specific calibration).

even without the basket software. The test results showed that the problems that develop in dowel baskets tend to be more obvious, larger scale problems that are easy to detect from the graphical output of MagnoProof (Figure 35). In general, the problems appear to be results of the baskets bursting open or deforming during concrete placement due to inadequate anchoring.

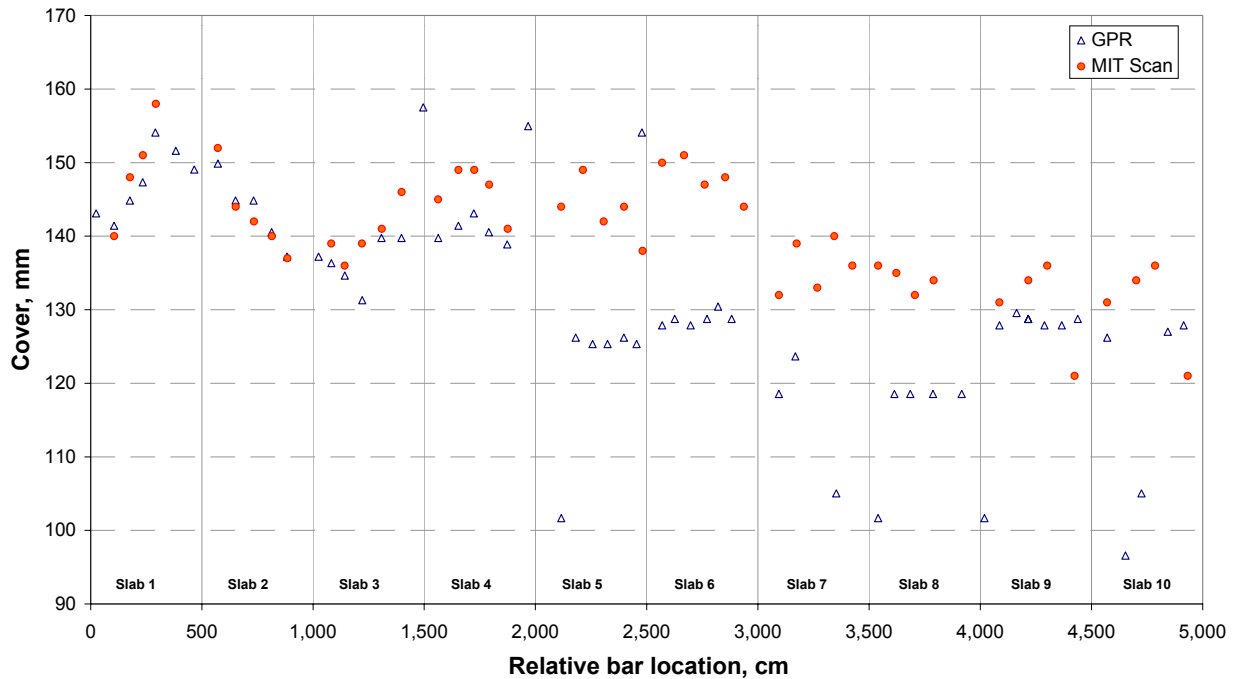
Figure 36. Comparison of GPR and MIT Scan-2 results from Kansas.

Because MIT Scan-2 results are a direct interpretation of the magnetic signals detected during testing, the bar location reported by the device is highly reliable. On the other hand, the GPR results depend on material properties used in the data evaluation. Since the material properties can vary significantly along the length of a project, localized errors are possible. Some of the bar positions reported by GPR appear to be in error. For example, in slab 7, GPR reported only three tie bars, and the bar spacing in slabs 8, 9, and 10 is highly variable, ranging from 0.5 to 129 cm (0.2 to 51 in.). Results are shown graphically in Figure 36.

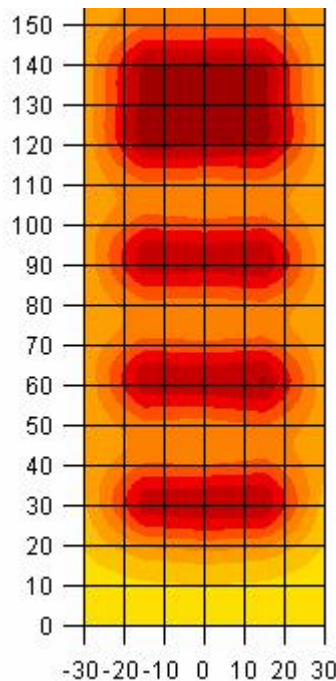
Figure 37. Signal intensity plot showing uncut ties between location 110 and 150 (cm).

The Missouri DOT was interested in a demonstration of MIT Scan-2, and a site visit could be conveniently coordinated with the visits to Kansas, Iowa, and Minnesota. A short presentation was made at the DOT office, followed by an open-air demonstration and a field demonstration. The field demonstration was made on an on-ramp under construction near the DOT office. Several transverse joints were scanned, along with one longitudinal joint. The dowel alignment was not a concern on this project. The scan results showed no major problem with dowel alignment. One noticeable feature on this project was that all joints had at least a few uncut ties, clearly visible on the signal intensity plot (Figure 37).

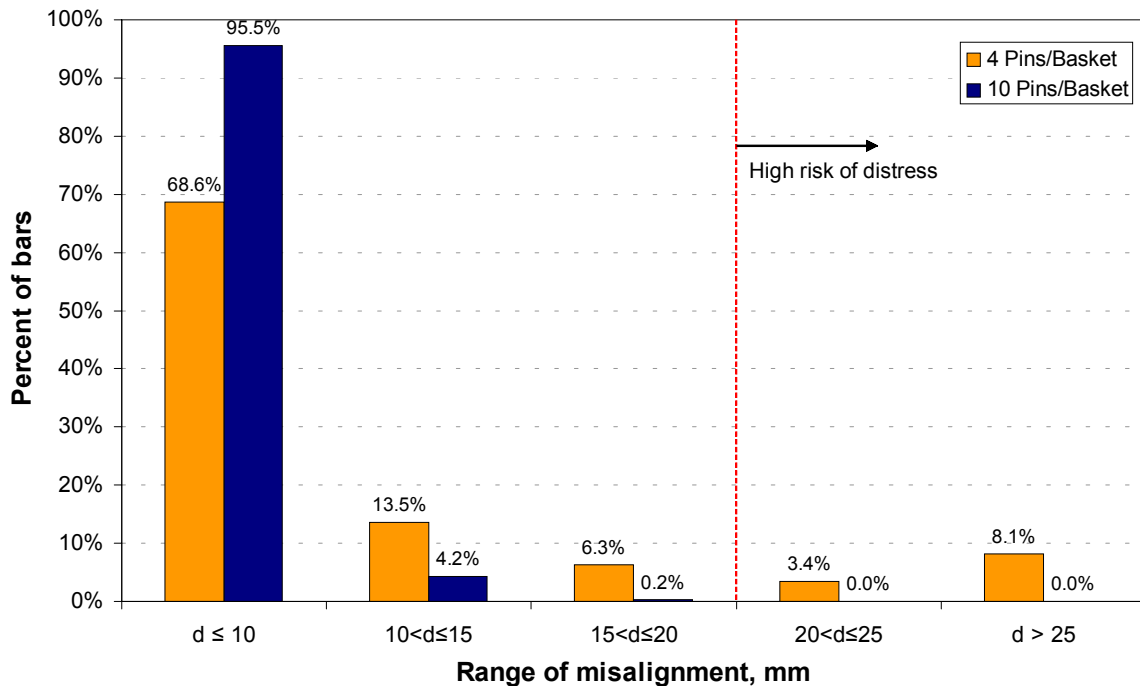
Figure 38. Comparison of dowel alignment for baskets anchored using 4 pins/basket and 10 pins/basket.

On this project, the baskets were originally anchored using only four pins per basket, one at each corner. MIT Scan-2 test results showed that these were not sufficient to hold the basket in place. Many baskets burst open, causing large misalignments. The most common problems observed from this project are shown in Figure 35b. Such problems are also clearly evident in the numerical results obtained using the standard software. The numerical results obtained without the proper calibration must be considered qualitative, but the results still provide an adequate degree of accuracy to clearly delineate the baskets that have problems and those that exhibit very good alignment.

After discovering the problem with the basket anchoring practice, the process was modified to pin every other dowel on each side of the basket (10 pins per basket). This change resulted in immediate and drastic improvement in dowel alignment. A comparison of the dowel alignment trends before and after the change is shown in Figure 38. Severely misaligned dowel bars can cause a joint to lock. Figure 38 shows that anchoring the baskets using only 4 pins per basket caused 11.5 percent of dowel bars to be misaligned by 20 mm (0.78 in.) or more. This is a severe case of dowel misalignment. If uniformly distributed, the 11.5 percent would place at least one severely misaligned dowel bar in every joint. By contrast, the baskets anchored using 10 pins per basket had exceptional alignment. No bars were misaligned by more than 20 mm (0.78 in.), and only 0.2 percent of the bars were misaligned by more than 15 mm (0.59 in.). These results represent about the best dowel alignment that could possibly be achieved in the field using either baskets or DBI. All sections anchored using 10 pins per basket showed similar results on this project.

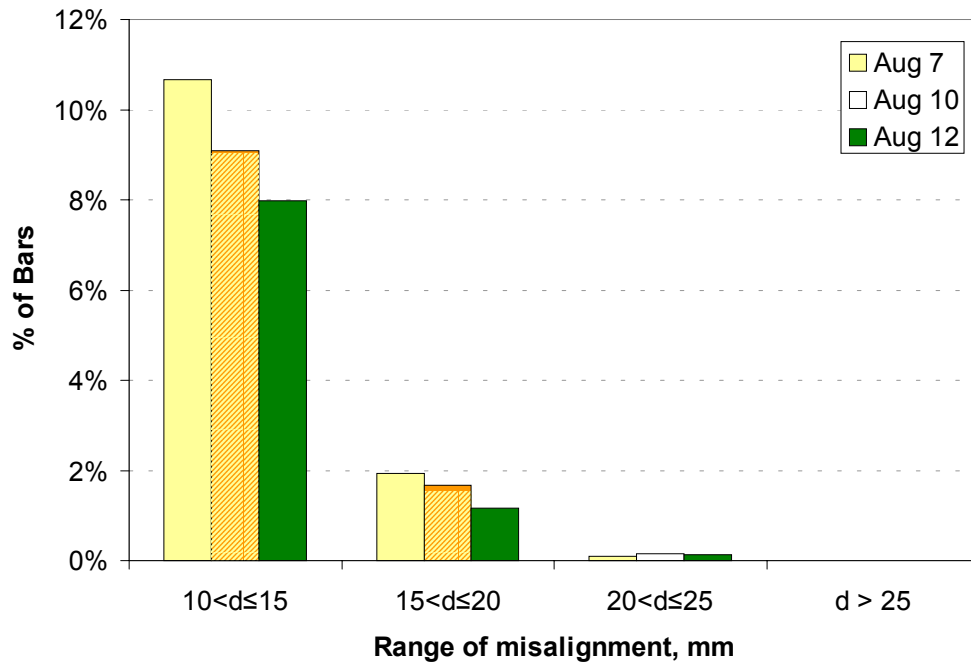
Figure 41. The effects of mix optimization on dowel alignment on the US-64 Bypass project.

For the contractor, MIT Scan-2 was also instrumental in refining paving operations. Problems with equipment adjustment were easily detected using the MIT Scan-2 results. For example, a consistently large misalignment at one particular bar position suggested that the DBI forks at that position needed adjustment. For construction using a DBI, concrete mixture proportions have a significant effect on dowel placement. The portland cement concrete (PCC) mixture must be stable enough to hold the dowel bars in place after the insertion, and the mixture must be workable enough to ensure that no voids are left behind as the dowel bars pass through the concrete to their final positions. The ability to rapidly monitor dowel placement results at consecutive joints was helpful in adjusting the mixture proportions (Figure 41). This project demonstrated the usefulness of the MIT Scan-2 for process control in real time.
