# Use of Magnetic Tomography Technology to Evaluate Dowel Placement

PUBLICATION NO. FHWA-IF-06-006

NOVEMBER 2005

6. Performing Organization Code	
7. Author(s) <b>H. Thomas Yu and L. Khazanovich</b>				8. Performing Organization Report No.	
9. Performing Organization Name and Address <b>ERES Consultants 505 West University Ave Champaign, IL 61820</b>				10. Work Unit No. (TRAIS)

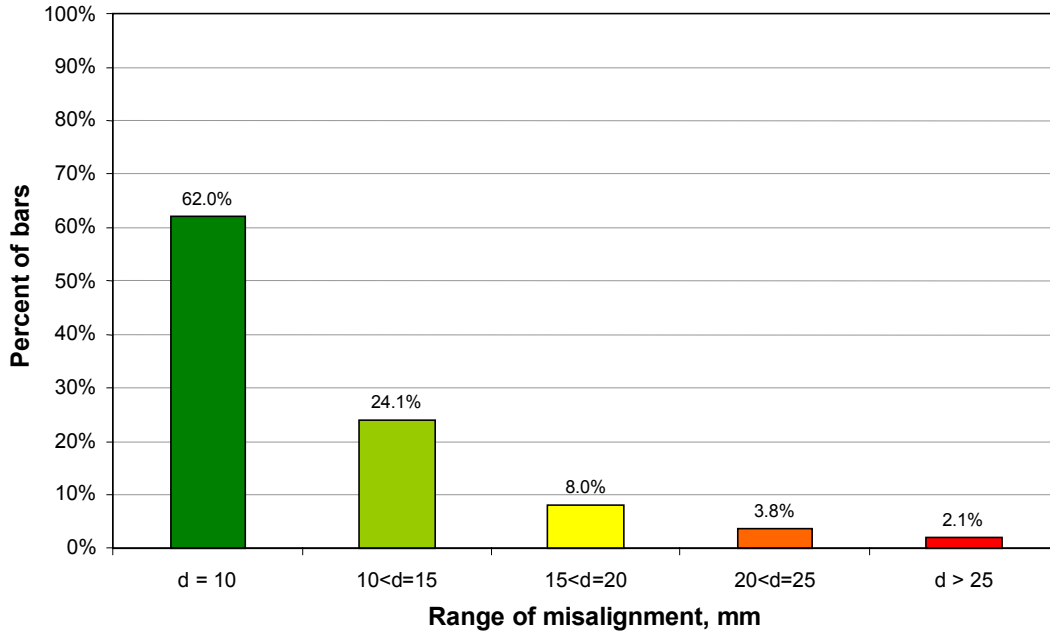
Figure 42. Distribution of dowel misalignment in the I-81 project in Pennsylvania (maximum of either horizontal or vertical misalignment).

The results are shown in Figures 42 and 43. As shown in Figure 42, this project contains what would appear to be a significant percentage of misaligned bars (misalignment > 20 mm [0.78 in.]). The Joint Scores for this project show that several joints on this project may be locked, but field experience shows that occasional locked joints can be tolerated (Yu 2005). Also, the joint locations on this project where cracking occurred did not have a high Joint Score.

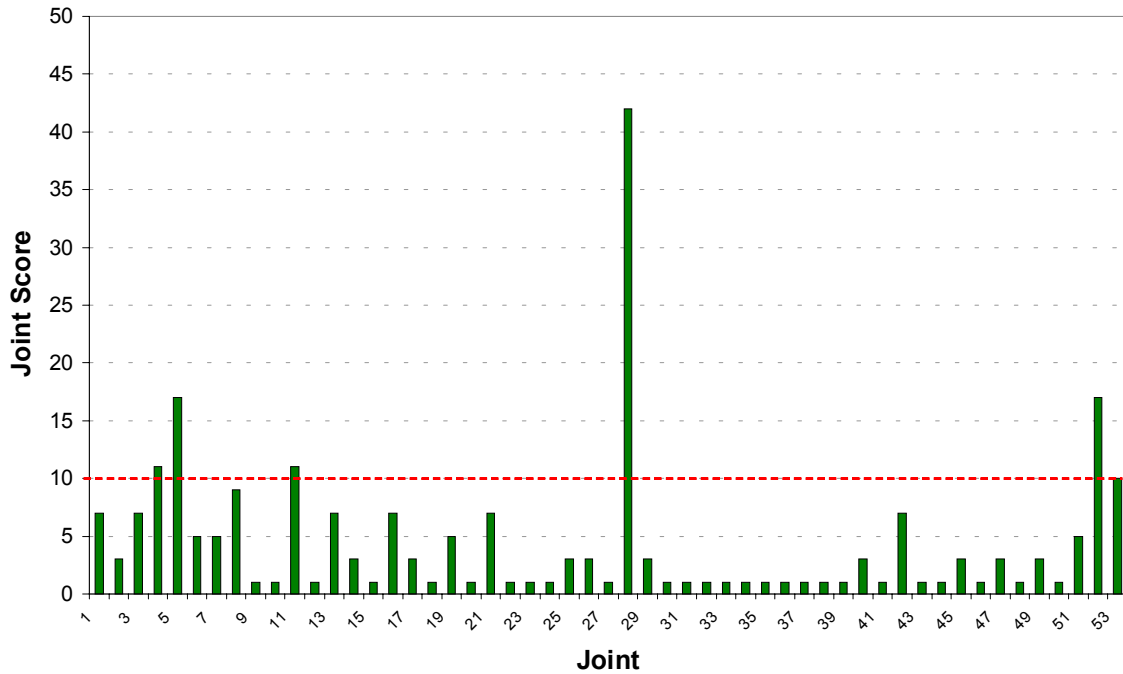
Figure 43. Joint Scores for the I-81 project in Pennsylvania.

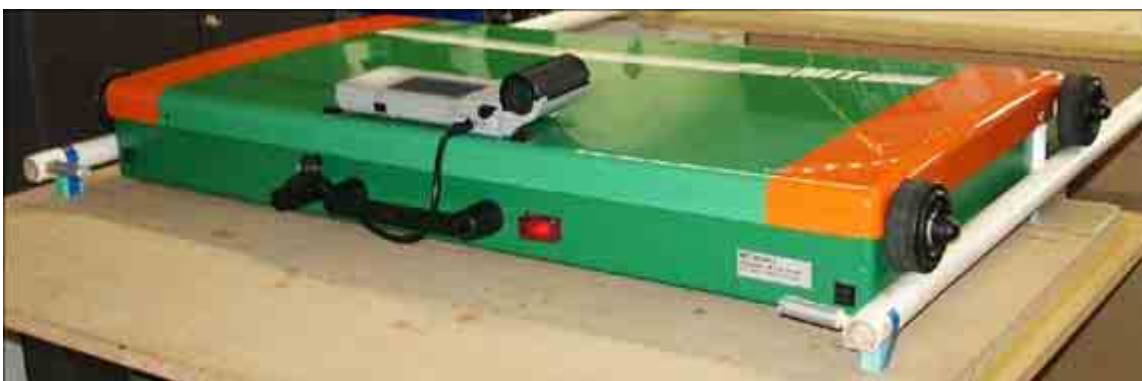
Figure A1. MIT Scan-2 device.

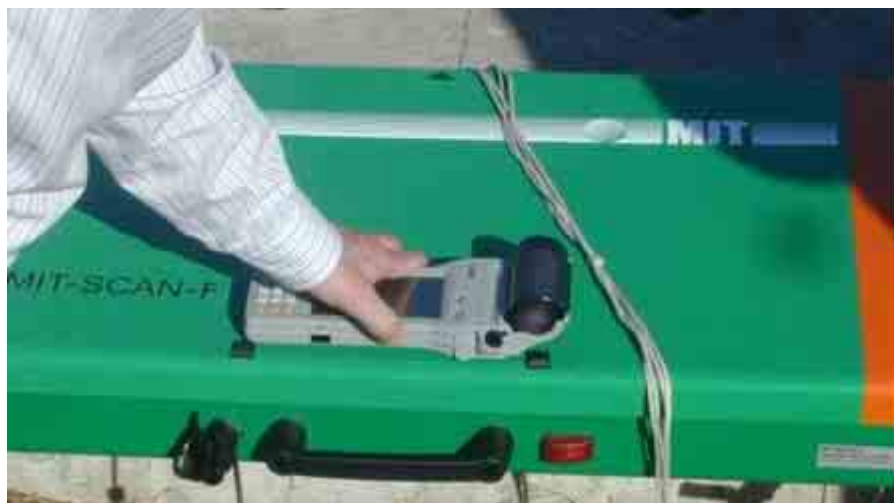
Figure A3. Proper placement of IT2000.

After the rail system is assembled, the scan unit should be placed on the rail and IT2000 placed on the scan unit at the designated place. The location of IT2000 is marked with rubber stoppers, as shown in Figure A3, and Velcro is used to hold the onboard computer in place.

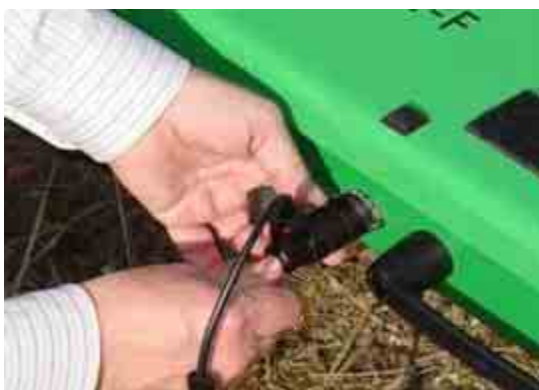
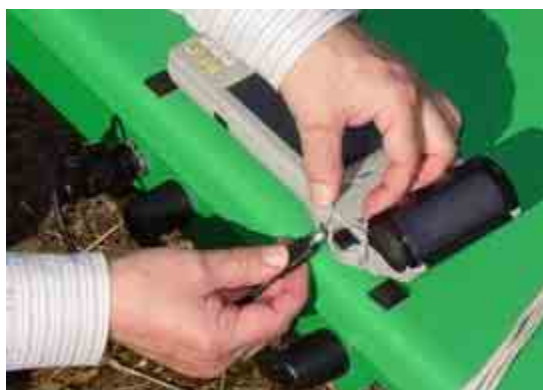
Figure A4. Connecting the data cable (a) at the scan-unit end and (b) at the IT2000 end.

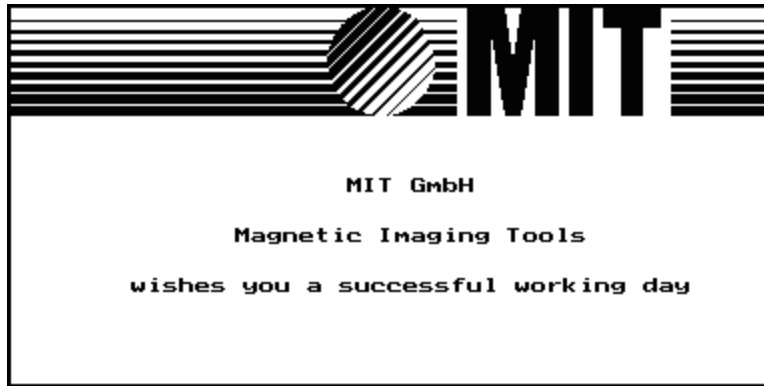
Figure A5. IT2000 display at power-up, when the sensors and communication link between IT2000 and the scan unit are working properly.

Switch on the IT2000 after installing the data cable. Figure A5 shows the screen that displays if all sensors and communication between the scan unit and IT2000 are working properly.

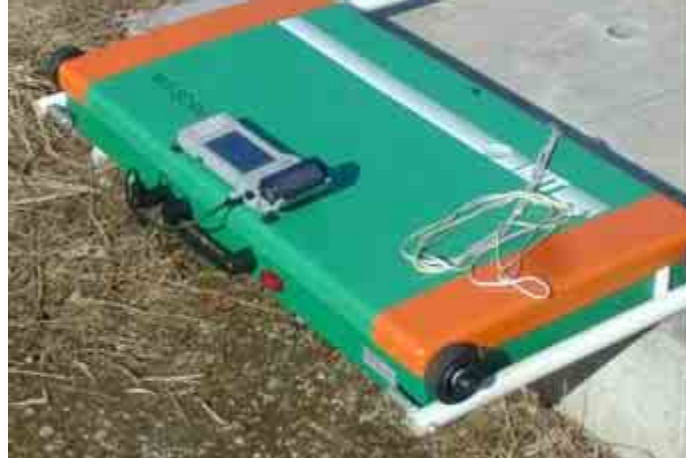
Figure A22. Properly positioned scan unit against the stopper for accurate determination of bar positions along the joint.

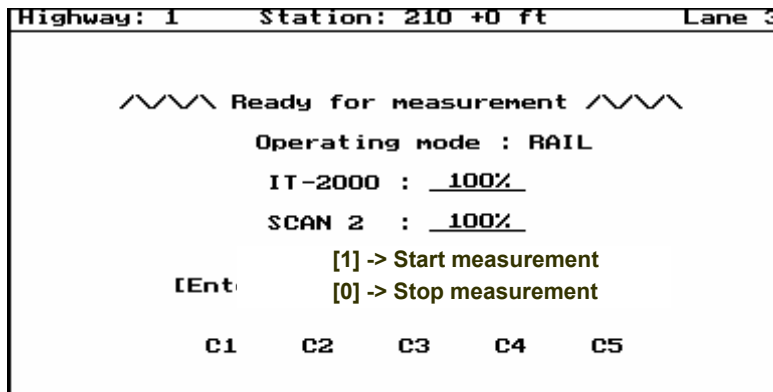
Figure A23. MagnoNorm screen when the device is ready for a measurement.

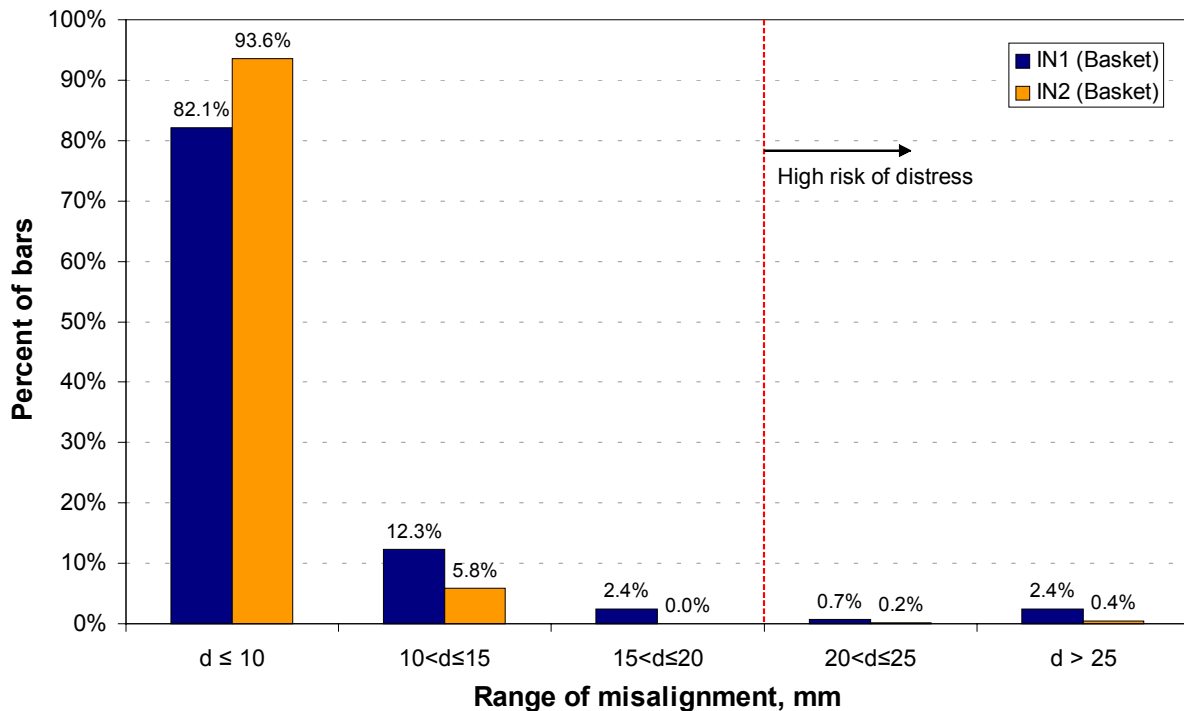
Figure B1. Example distribution of dowel misalignment (maximum horizontal or vertical) by range of misalignment (Yu 2005).
